# 発掘調査成果と表示

# Excavation result

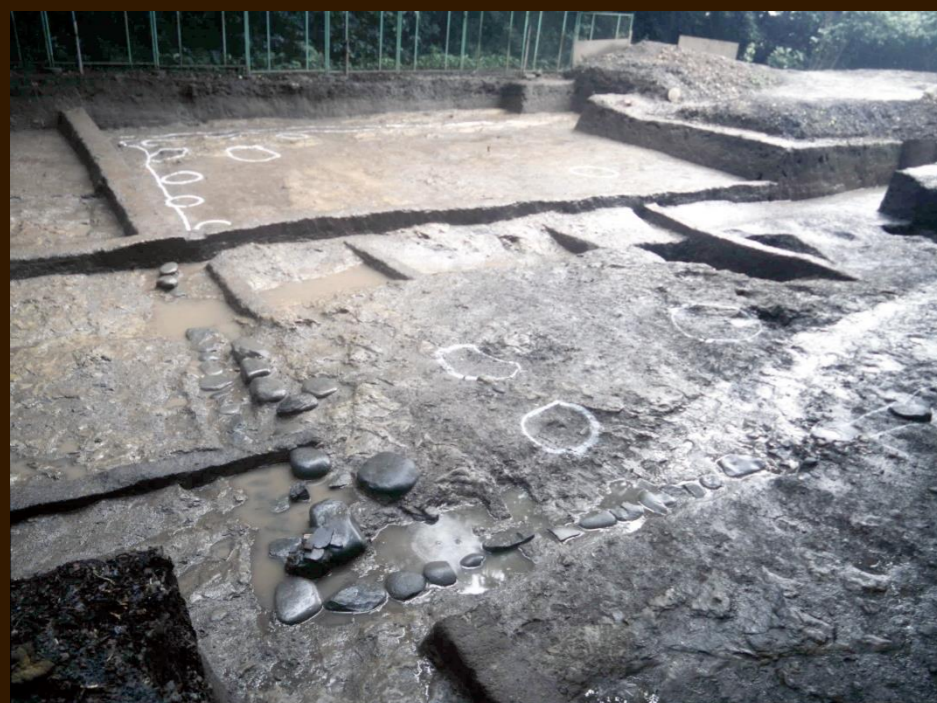
発見された建物跡（北西から）

Remains of Hojo Yoshitoki's Hokkedo Buddha Hall  
(photo taken from the northwest during the excavation)

平成 17 年(2005 年)に行った発掘調査によって、建物の縁束の礎石、雨落溝、柱を支える礎石を据えていた痕跡が発見され、この場所に一辺が 28 尺(8.48m)のお堂が建っていたことが明らかになりました。調査では瓦が出土していることから、瓦葺の建物であったと考えられます。また、一緒に出土したかわらけなどの遺物の年代から、建物は 13 世紀末から 14 世紀初頭頃には使われなくなっていたこともわかりました。

As a result of the excavation survey in 2005, in which foundation stones of a porch, a rain ditch and remains of foundation stone supports for pillars were found, it became clear that there used to be a square hall (8.48m per side) in this place. Due to the tiles unearthed during the excavation, it is thought that it was a tile-roofed building. From the age of the relics (like earthenware) found here and the geographical information described in the literature, it is estimated that these are remains of Hojo Yoshitoki's Hokkedo Buddha Hall (wooden temple-shaped mausoleum), built in the early 13<sup>th</sup> century.

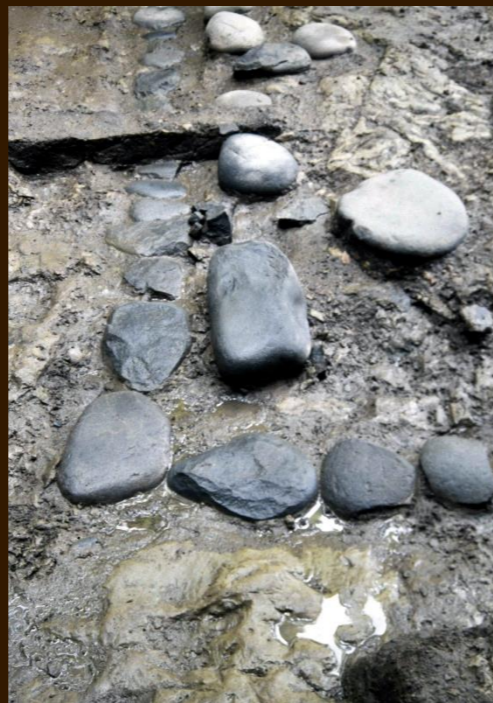
縁束の礎石と雨落ち溝

Foundation stone  
and rain ditch

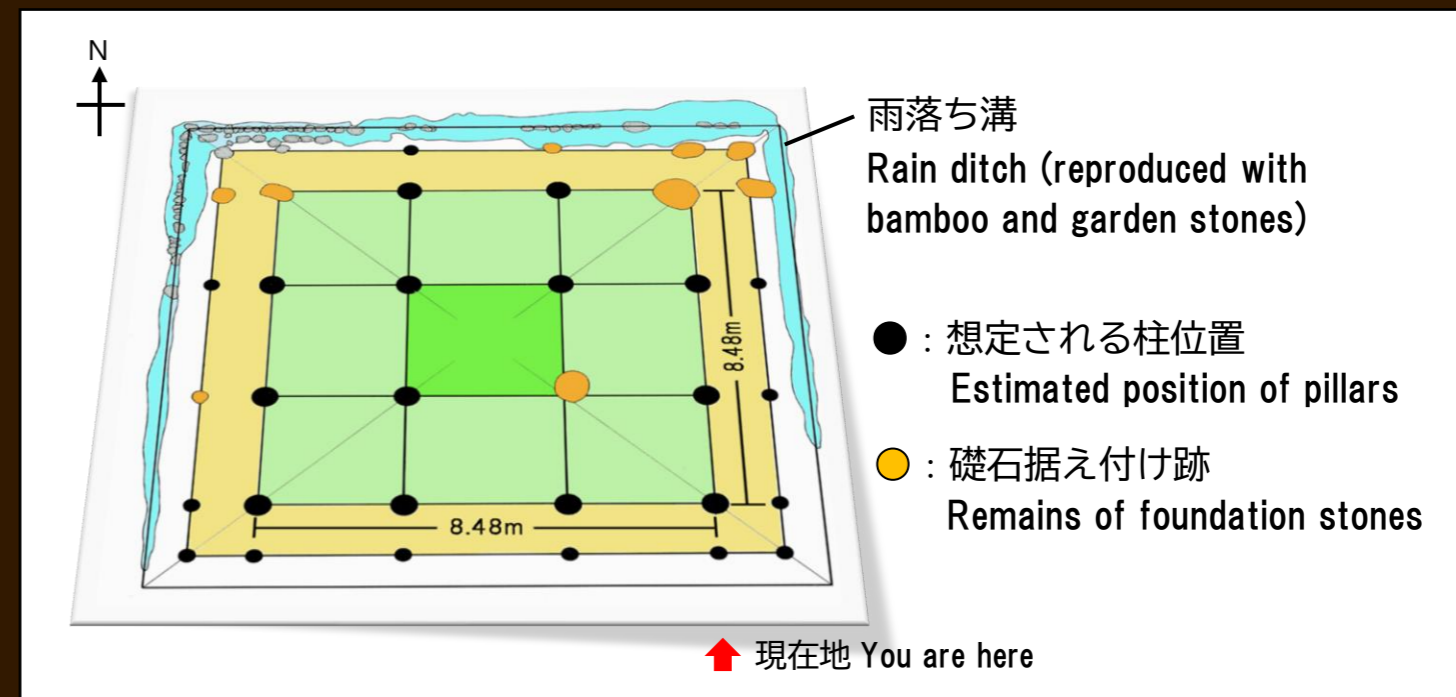
法華堂跡復元平面図 Ground plan of excavation results

正面の地面には、その建物の柱の位置を杭と石で、雨落溝を玉砂利で示しています。
