鎌倉の埋蔵文化財10

平成17年度発掘調査の概要

平成19年3月
鎌倉市教育委員会

わかみやおおじしゅうへんいせきぐん 1 若宮大路周辺遺跡群 (小町一丁目276番18ほか地点)

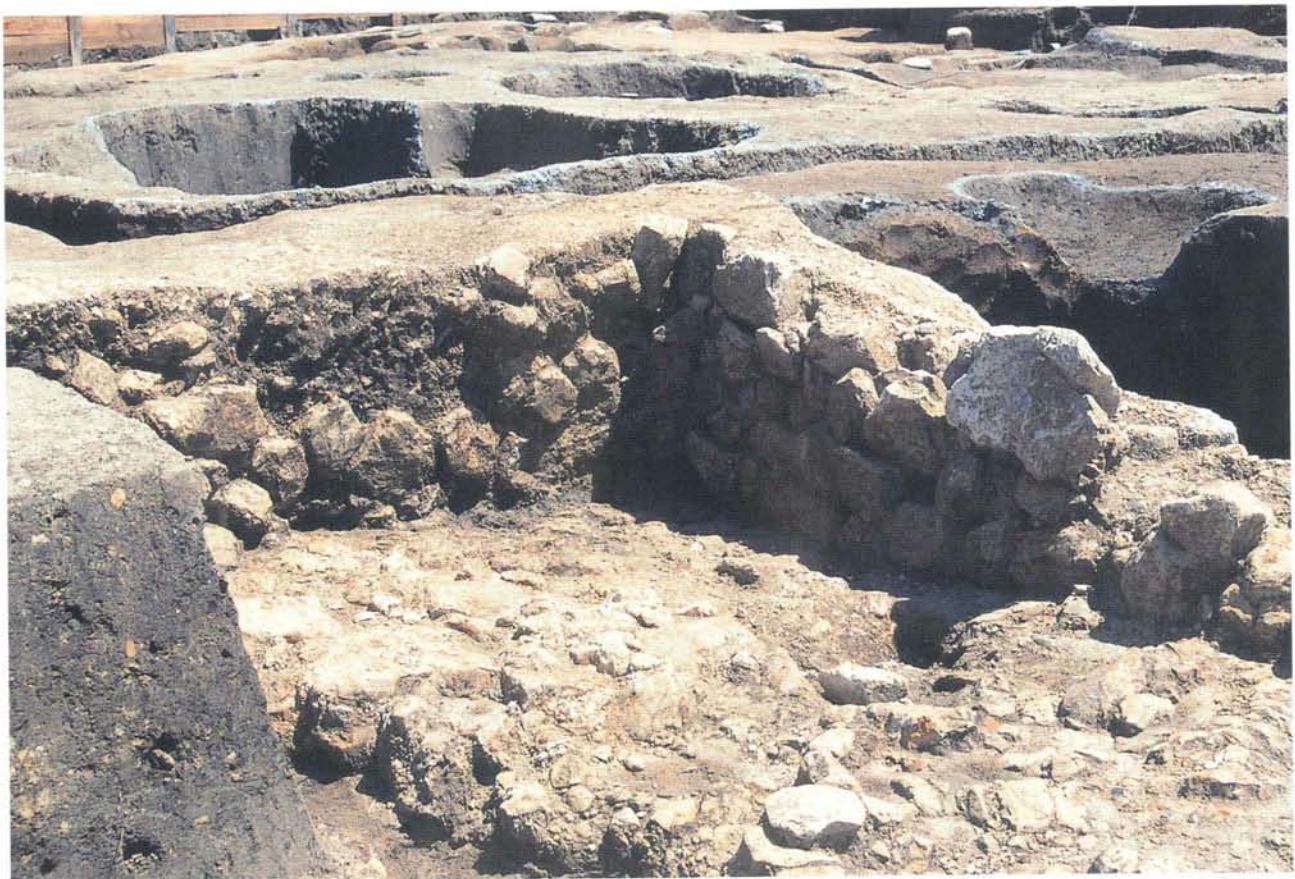
方形竪穴建築址 5
The sunken square pit dwelling remain No. 5

若宮大路周辺遺跡群は、若宮大路を中心として東は滑川、西は今小路までひろがる都市遺跡です。調査地は、若宮大路と横須賀線が交差するガードの東側、扇川の左岸脇に所在します。ここでは平成17年度に実施した発掘調査によって、13世紀初頭から14世紀にかけての遺構が発見されました。方形竪穴建築址は鎌倉で度々発見されますが、今回発見された方形竪穴建築址5と名付けられた遺構は、地下部分の壁に土丹をきれいに積み重ね、床面にも土丹を敷き詰めたものであり、これまで類例はありません。このほか、本調査地点では土丹を敷き詰めた方形竪穴建築址が発見されています。また、調査地点は、東西が溝で区画されています。土丹を使った方形竪穴建築址が溝の西側に集中していることも、当時の土地利用を考えるうえで大きな特色といえましょう。このほかに、井戸や土坑などが発見され、韓半島からもたらされた高級な磁器や国産の陶磁器、「かわらけ」、漆器、鋳造に使ったと考えられる鋳型などが出土しました。

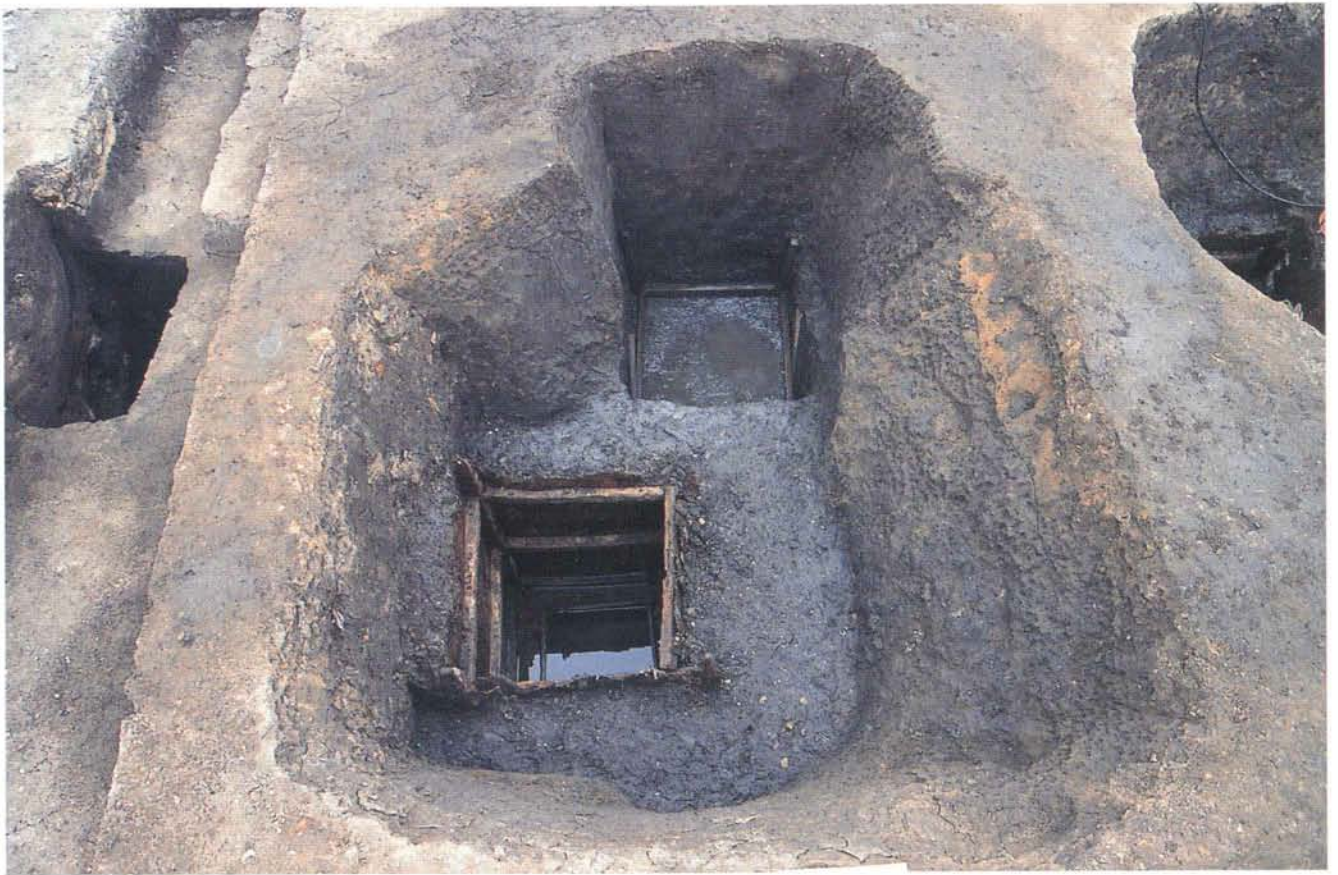
井戸 7・井戸 9
Well No.7 / Well No.9

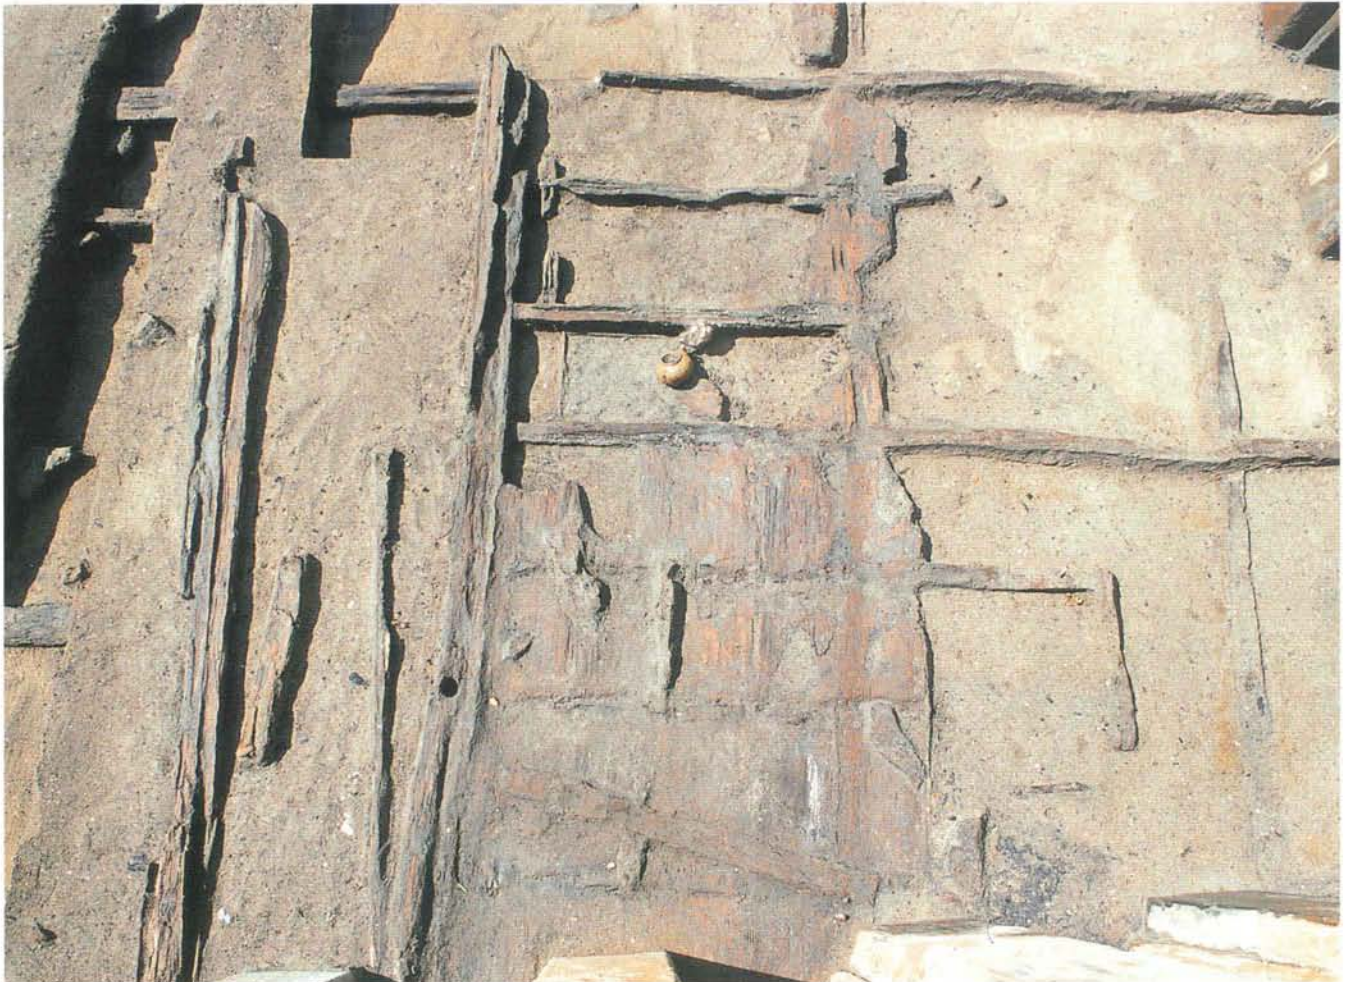
方形竪穴建築址

A sunken square pit dwelling remain

2～4ページでご紹介した調査地点と同じ若宮大路周辺遺跡群の範囲内ですが、この発掘調査地点は今小路をはさんで御成小学校の向かい側になります。この場所は、平成17年度に実施した発掘調査によって、68棟もの方形竪穴建築址が発見されました。これら建物は、出土した遺物からみると13世紀後半以降に建てられたと考えられ、このことから、今回の調査地点付近は13世紀後半になってから急速に土地利用が進んだことがわかりました。以降、15世紀にいたるまでの遺構・遺物が見つかりました。

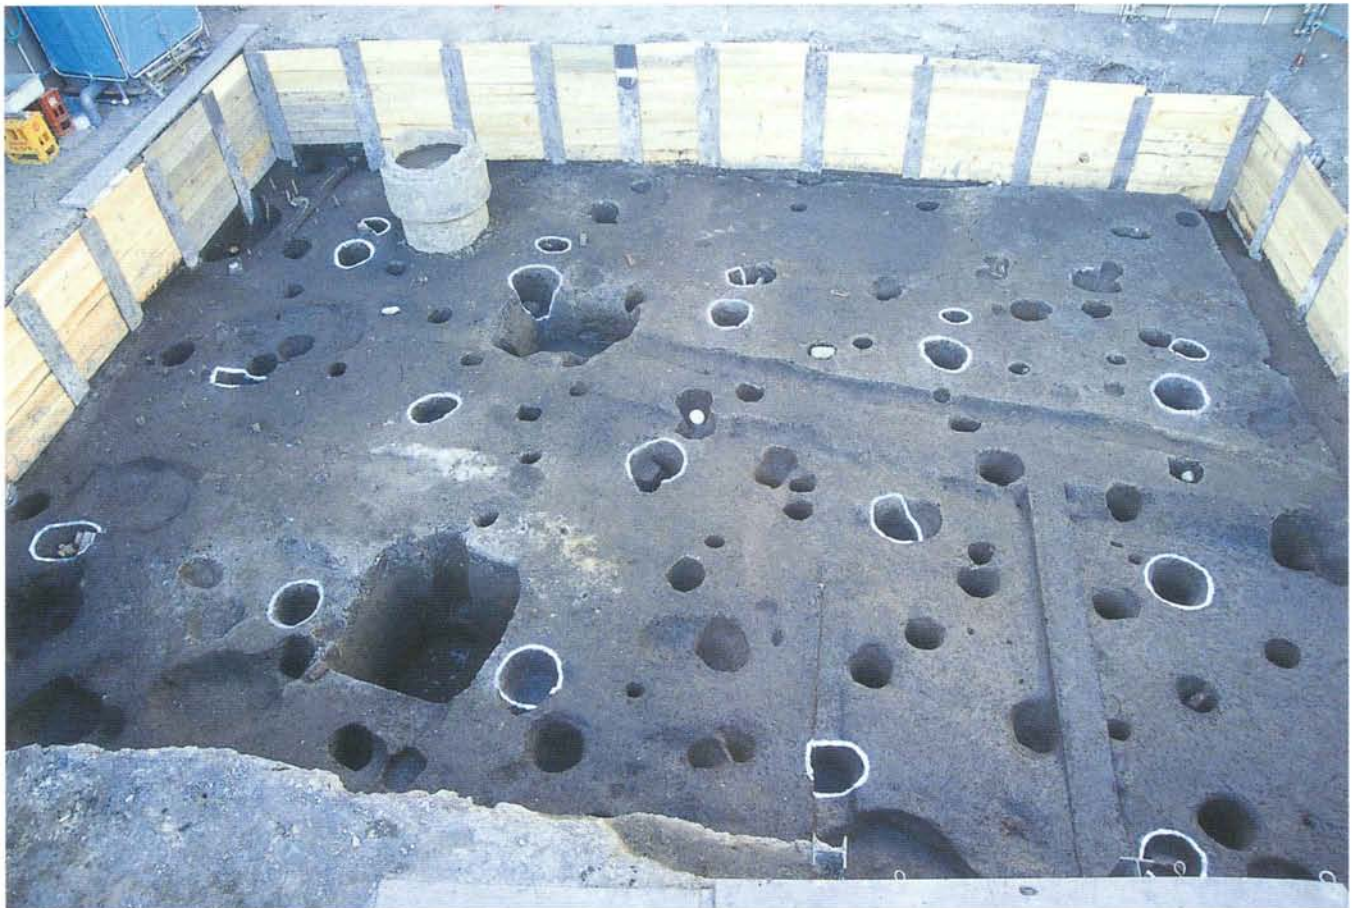
若宮大路周辺遺跡群発掘調査区全景

Full view of the excavated area in the sites surrounding Wakamiya-Oji

発見された遺構のなかでも、溝3は幅約70cm以上、深さ84cmの立派な溝で、若宮大路と直交する位置関係にあることから、若宮大路を中心とした街割りの様子がうかがえる遺構として興味深いものです。⁽²⁾ また、見つかった掘立柱建物1・2は4間以上×4間以上、掘立柱建物3・4は4間以上×6間以上と大型であり、いずれも建物の軸線が若宮大路に直交していました。⁽³⁾ このことから、調査地点にあった屋敷は、南北に走る若宮大路を意識して営まれていたようです。遺物としては、「かわらけ」、愛知県の渥美でつくられた陶器、中国の浙江省でつくられた磁器などが出土しています。

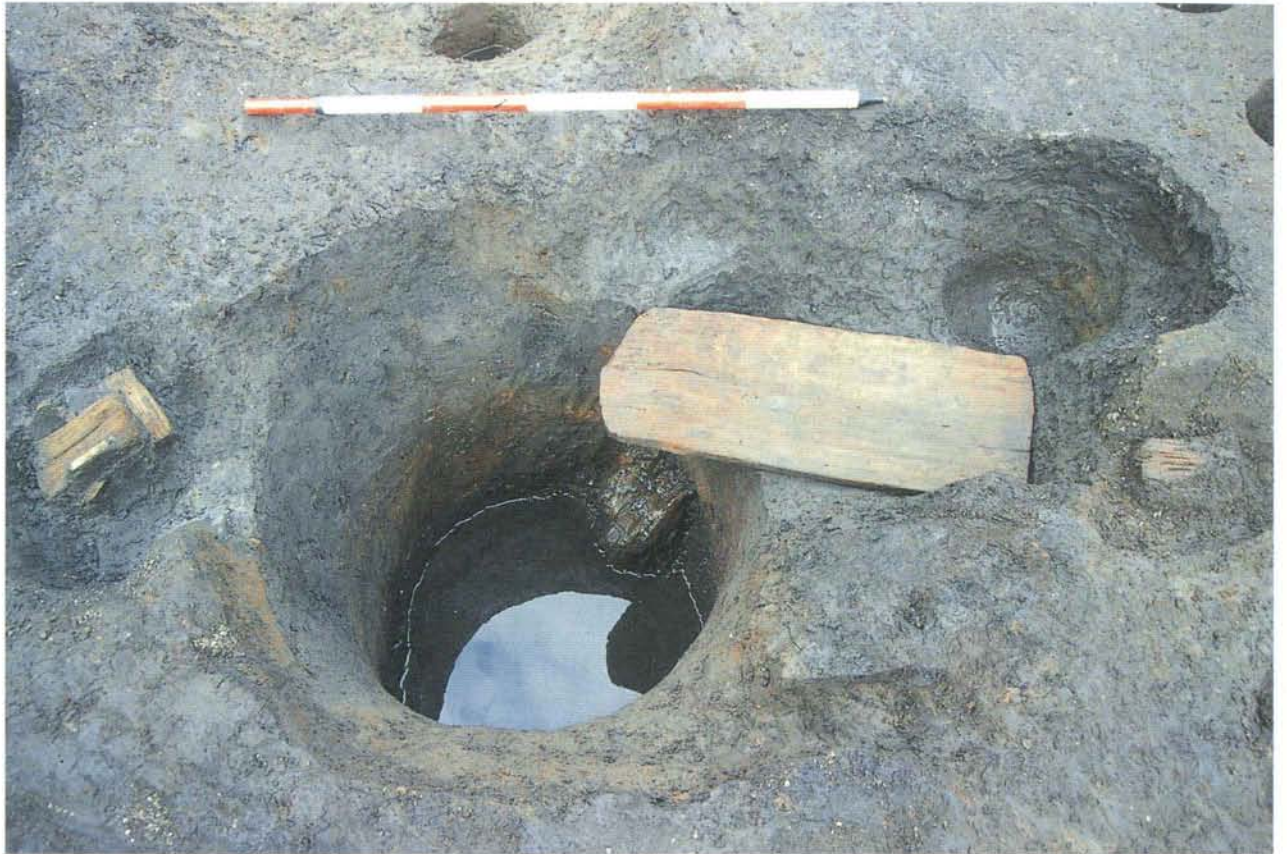
井戸と板材

A well and a wooden board

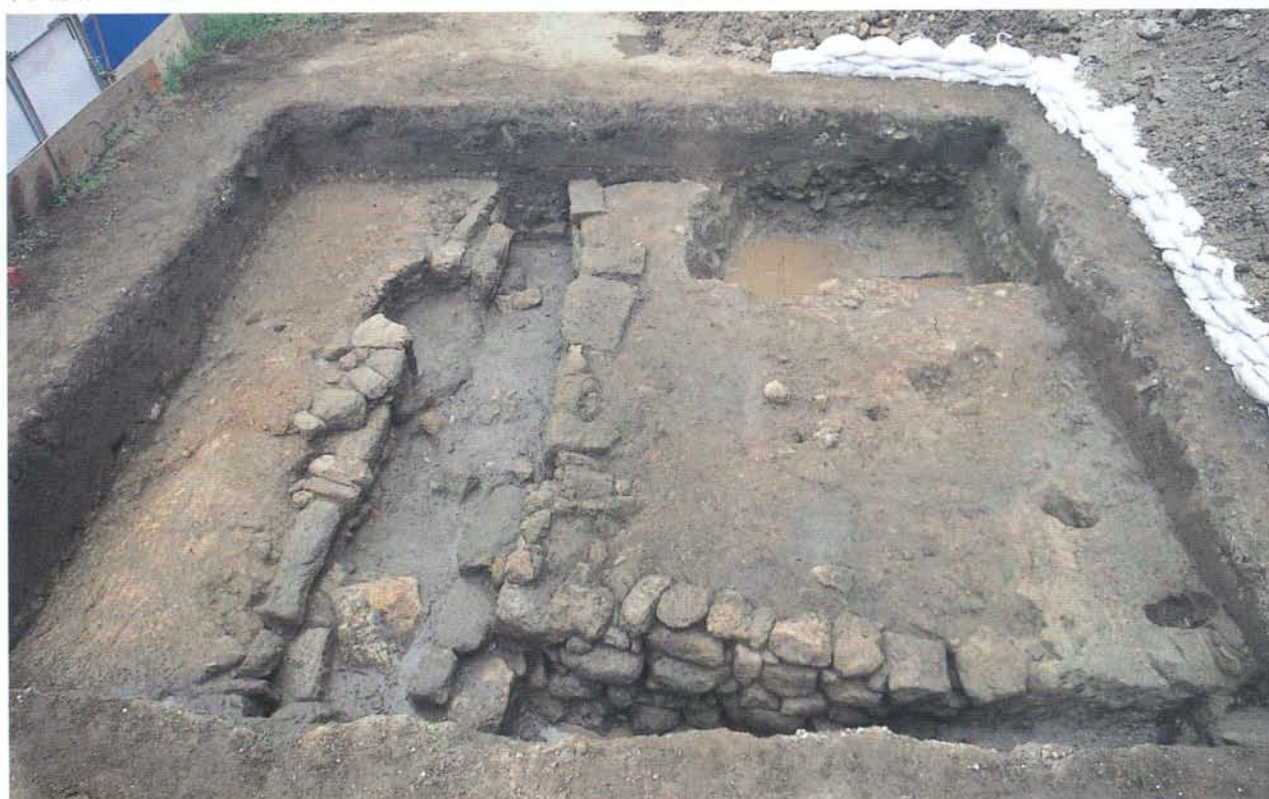
清涼寺跡発掘調査区全景

Full view of the excavated area in the site of Seiryouji Temple

発掘調査の結果、^{かまくらいし}鎌倉石の^{きりいし}切石を使用した溝が発見されました。溝の西側は^{ていせい}丁寧⁽²⁾に切り出した切石を^{せいぜん}整然と積み重ねていますが、東側はやや雑な積み方になっています。その理由として、溝の東側に道路と考えられる土丹を敷き詰めた跡が見つまっているため、西側の石積みは道路から立派に見せるための視覚的効果をねらったことが想像されます。逆に東側は、人目につかないことから雑な積み方にしたのかもしれない。

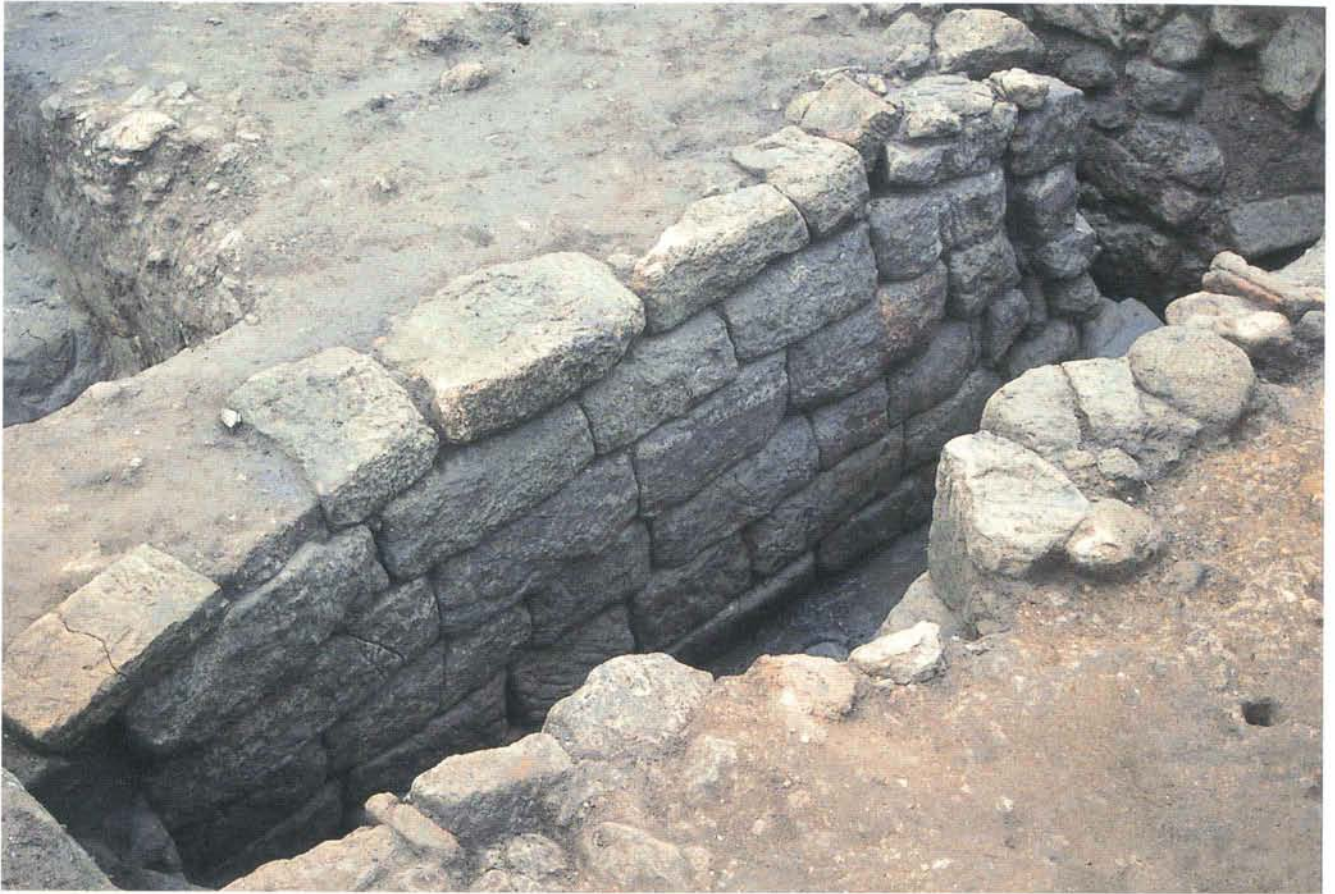
溝石積み
A gutter of piled stones

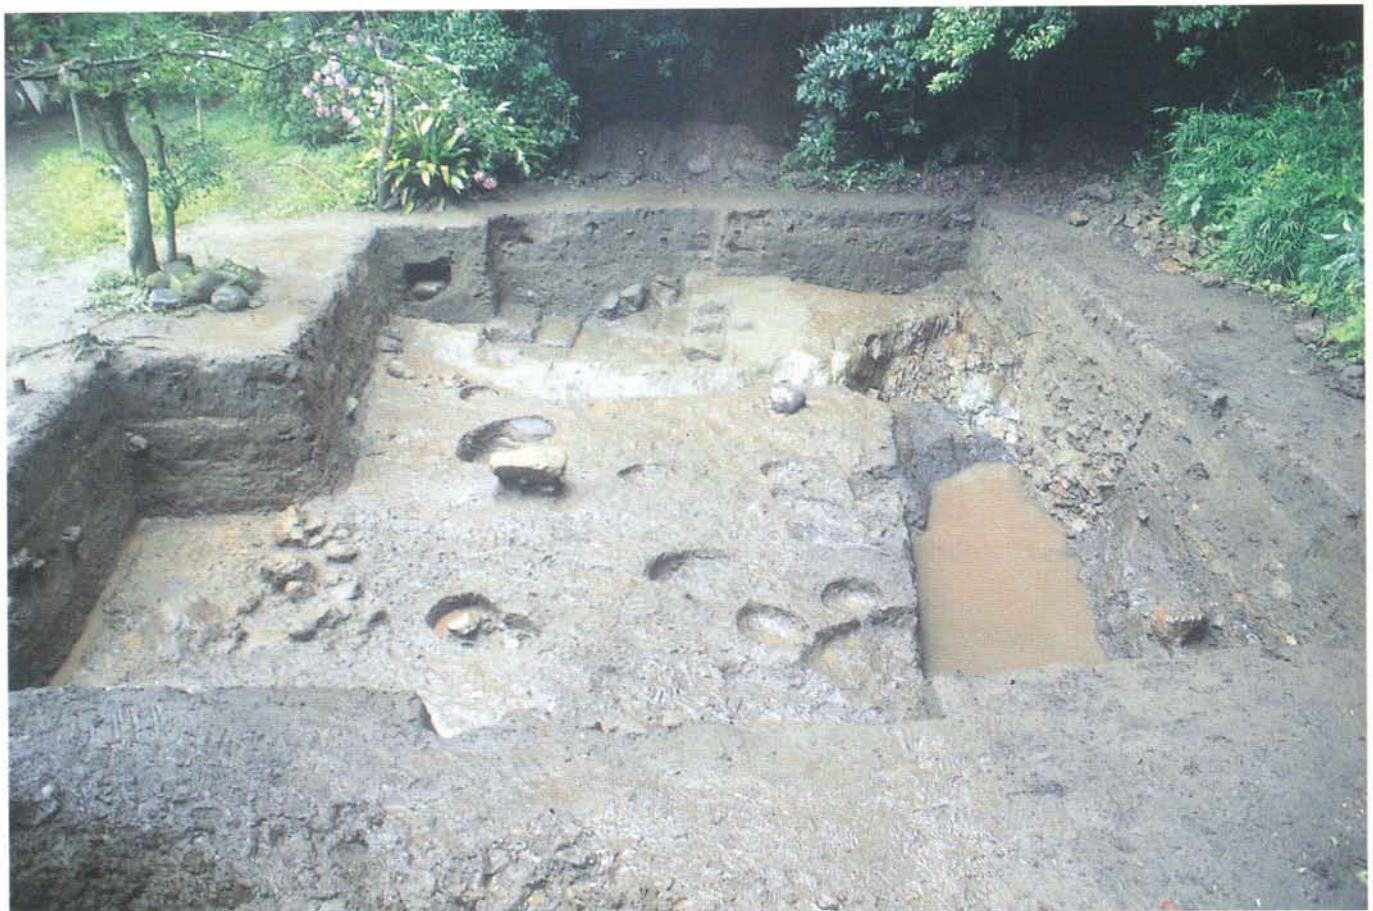
宝蓮寺跡発掘調査区全景

Full view of the excavated area in the site of Hourenji Temple

遺構としては、鎌倉石を使用し、13世紀中頃に営まれたと考えられる礎石建物^{そせきたてもの}が発見されました。重量のある立派な建物があったのでしょうか、中世で礎石建物⁽²⁾というとまず寺院建築^{じいんけんちく}が考えられますので、調査地点周辺の谷戸の土地利用に寺院が関わっていたことが想像されます。ただ、その寺院を宝蓮寺と断定することはできません。このほか、調査区北側では石切場の跡^{いしきりば}が見つかり、谷戸が切り拓かれていく様子^{どるい}がうかがえます。13世紀の終わりになると礎石建物⁽³⁾はなくなり、南北方向に土塁状^{どるい}の遺構⁽³⁾がつくられます。土塁状遺構⁽³⁾の側面は、両方とも基礎部分に大型の土丹が並べられ、その内側は土丹と土をつき固めながら盛土^{せきせいひん}しています。遺物としては、「かわらけ」、陶磁器^{とうじき}、石製品^{せきせいひん}、鉄製品^{てつせいひん}、銭^{ぜに}などが出土しました。

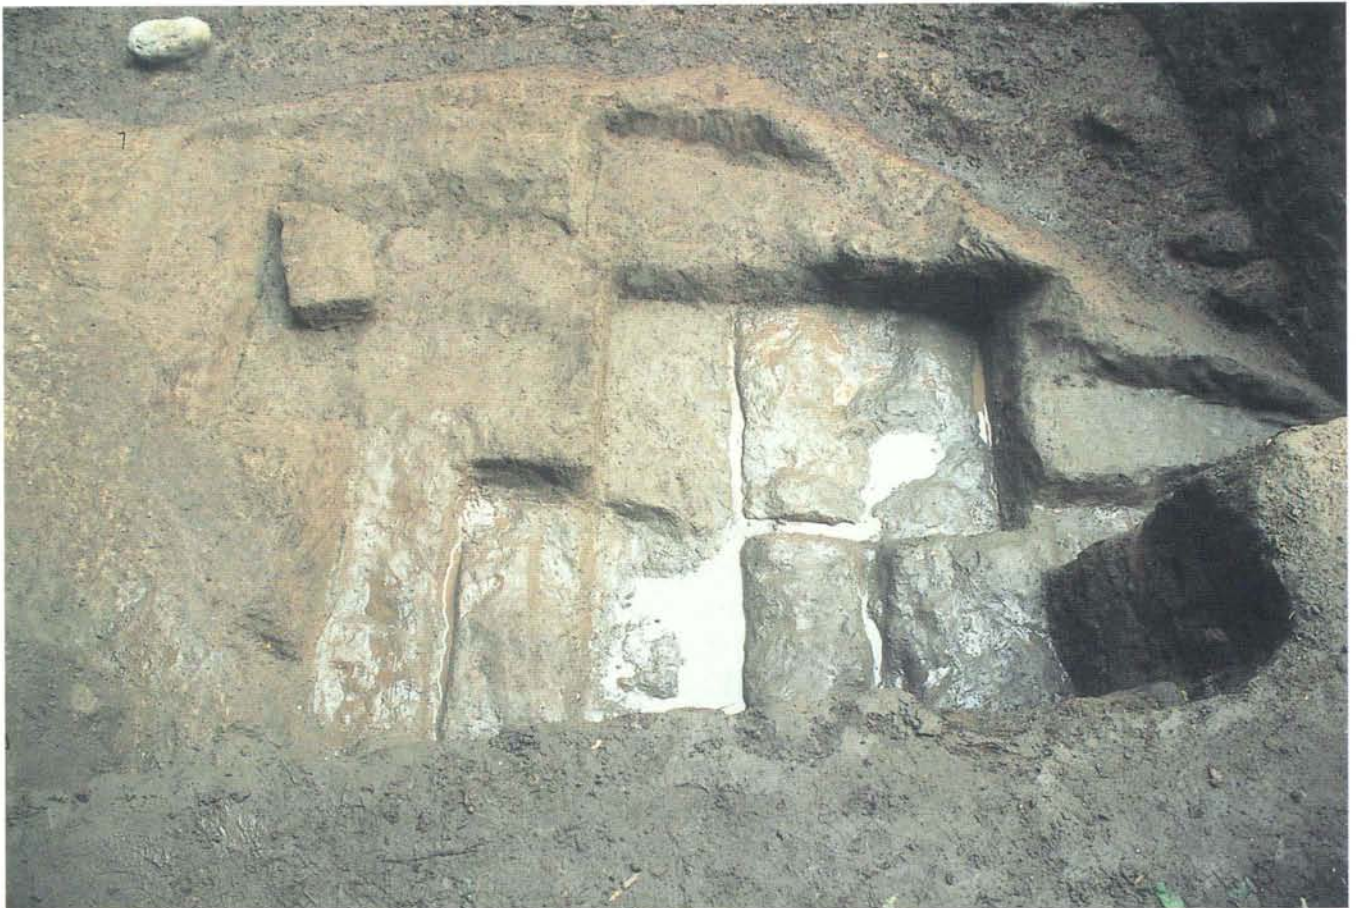
石切場跡

A remain of quarry
